USAAVRADCOM TR 78-2

AD A 054906 **FIELD EVALUATION OF THE SHOCK PULSE TECHNIQUE TO UH-1H SERIES HELICOPTERS**

5 JUNE 1974

FINAL REPORT

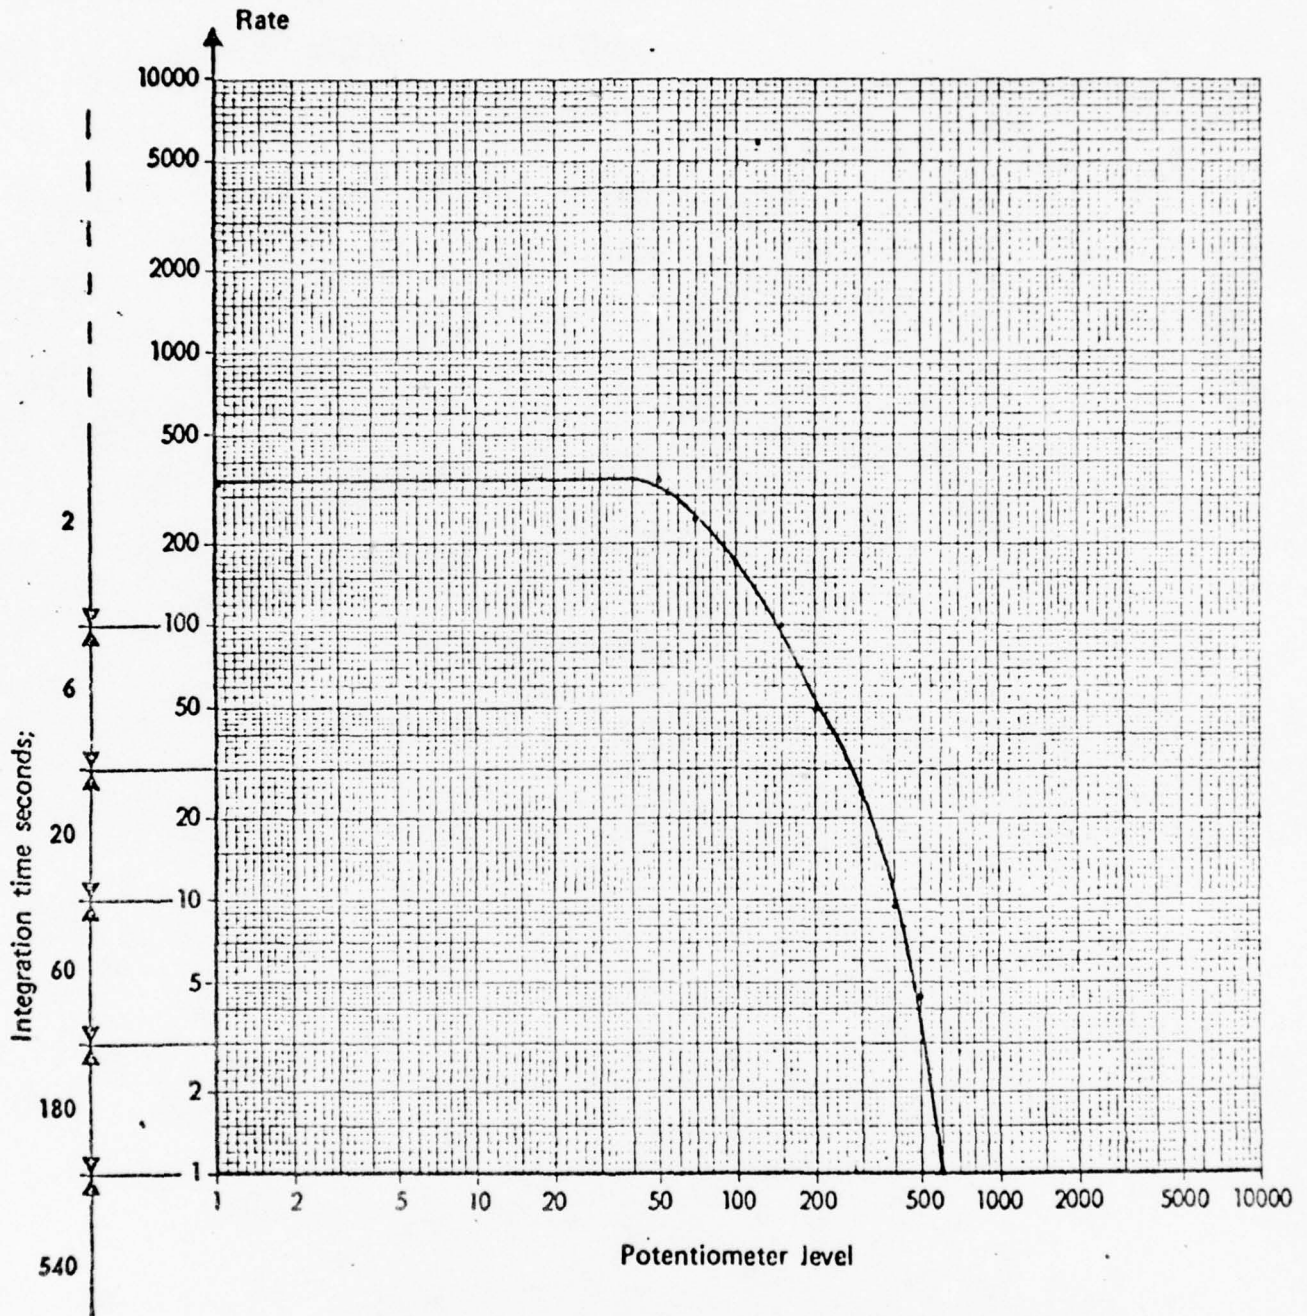
FIG. 2

BEARING SERIAL #A20-67523 REMOVED FOR PHYSICAL ANALYSIS.

404 hour since overhaul: 806 since new. "General condition good."

Corrosion evident in outer race adjacent to most balls, scratches across race adjacent to corrosive area.

SKF analysis showed shock level of 600 with shock rate of 340. Bearing damage appears to be caused by normal wear and use exposed to the general environment. Damage could not be considered excessive. Considering the teardown analysis of the bearing correlated with the MEPA-10A depiction, we would consider the depiction in rate and level would be approaching an unacceptable condition.

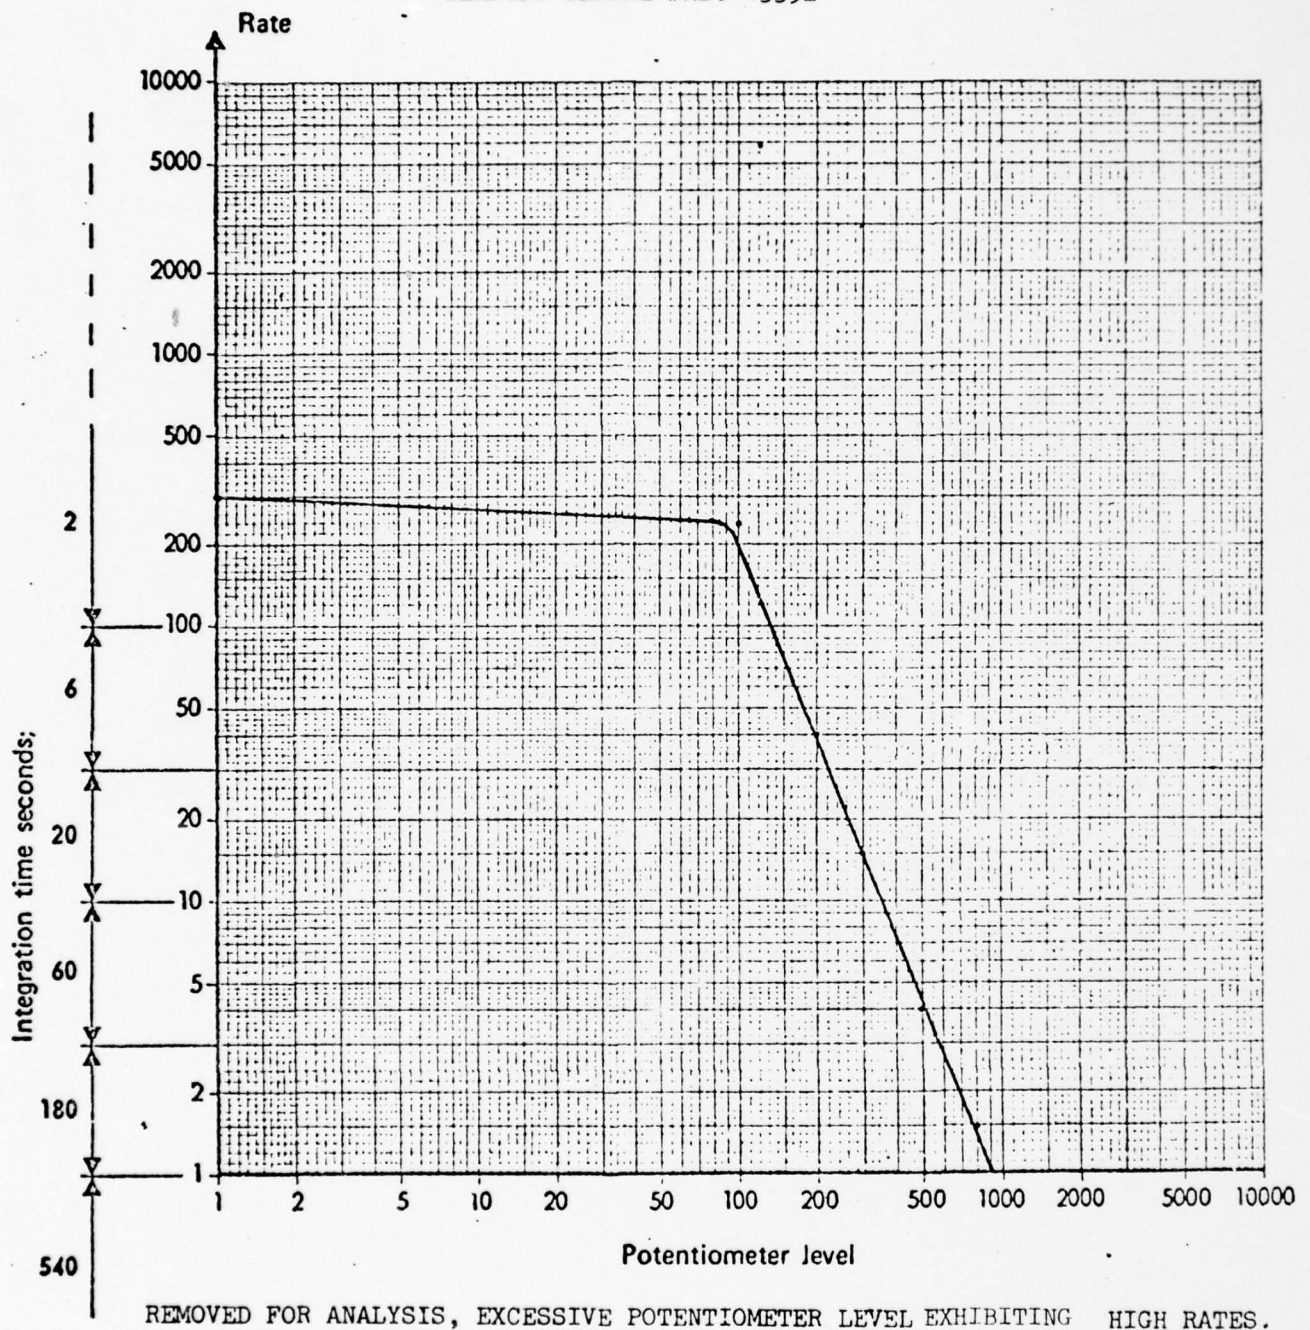
FIG. 13

REMOVED FOR ANALYSIS, EXCESSIVE POTENTIOMETER LEVEL EXHIBITING HIGH RATES.

The outer race of this bearing showed evidence of corrosion and pitting.

No damage was apparent in the inner race, however, one ball had corrosion.

The MEPA-10A shock analysis of this bearing showed high levels of damage. The level reached of 900 is in the higher 20% of the readings taken of all hanger bearings tested. Rate level of 300 is not excessive considering the bearings tested. Reviewing the MEPA-10A depiction, this bearing would fit in a classification showing damage requiring action.

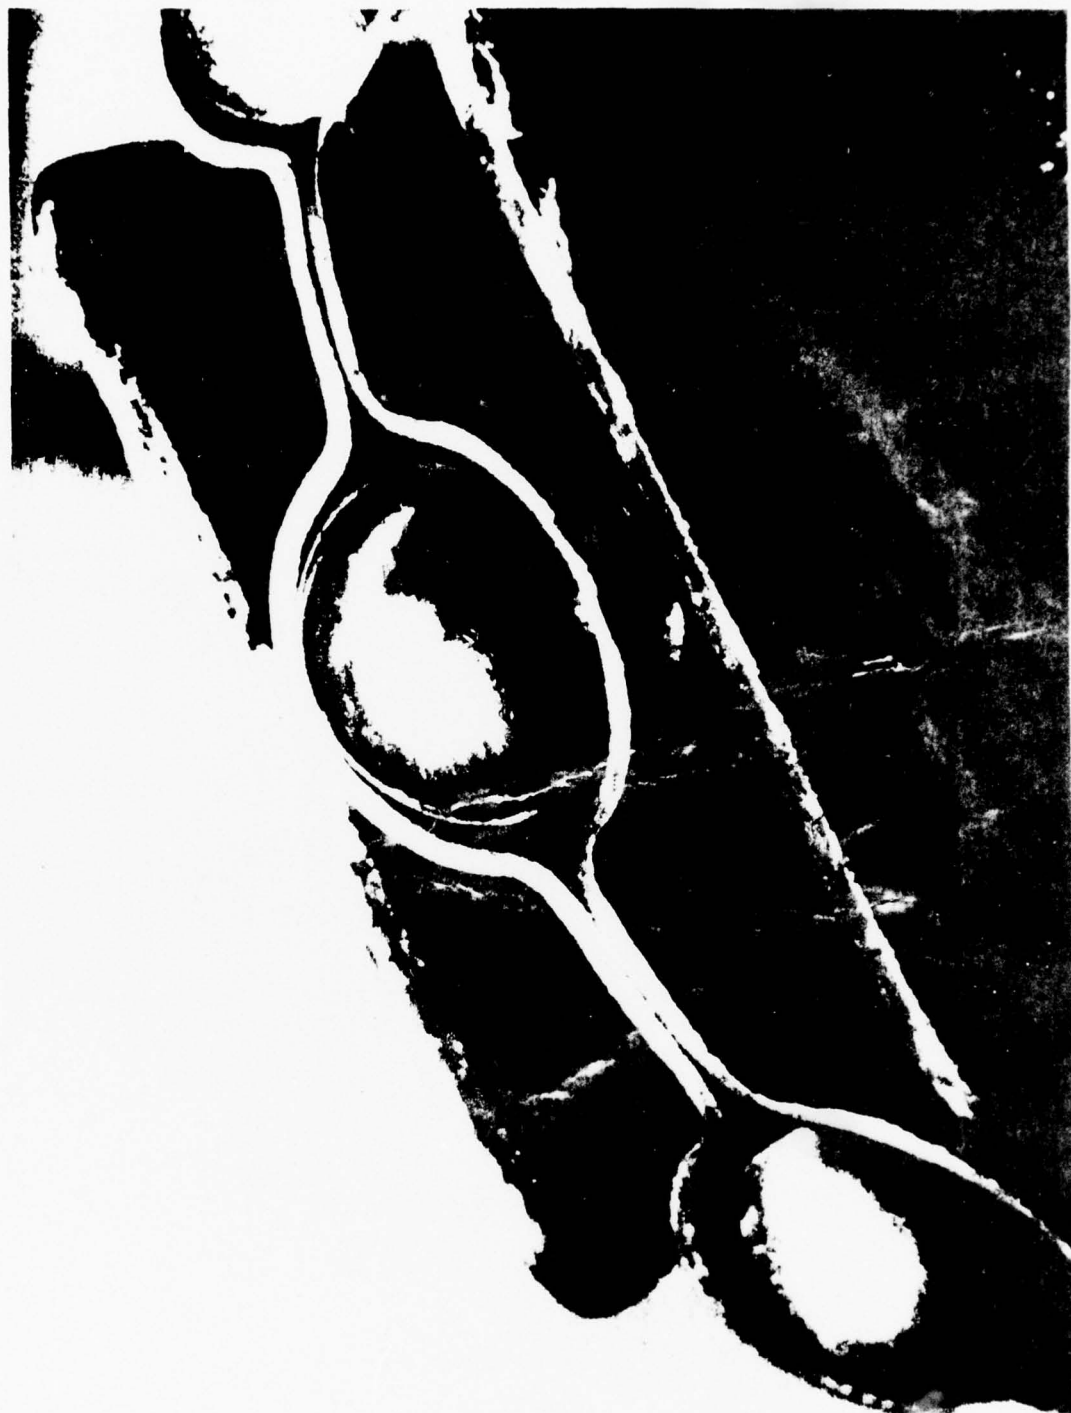
FIG. 13C

A20-43391 - Corrosion on Ball:

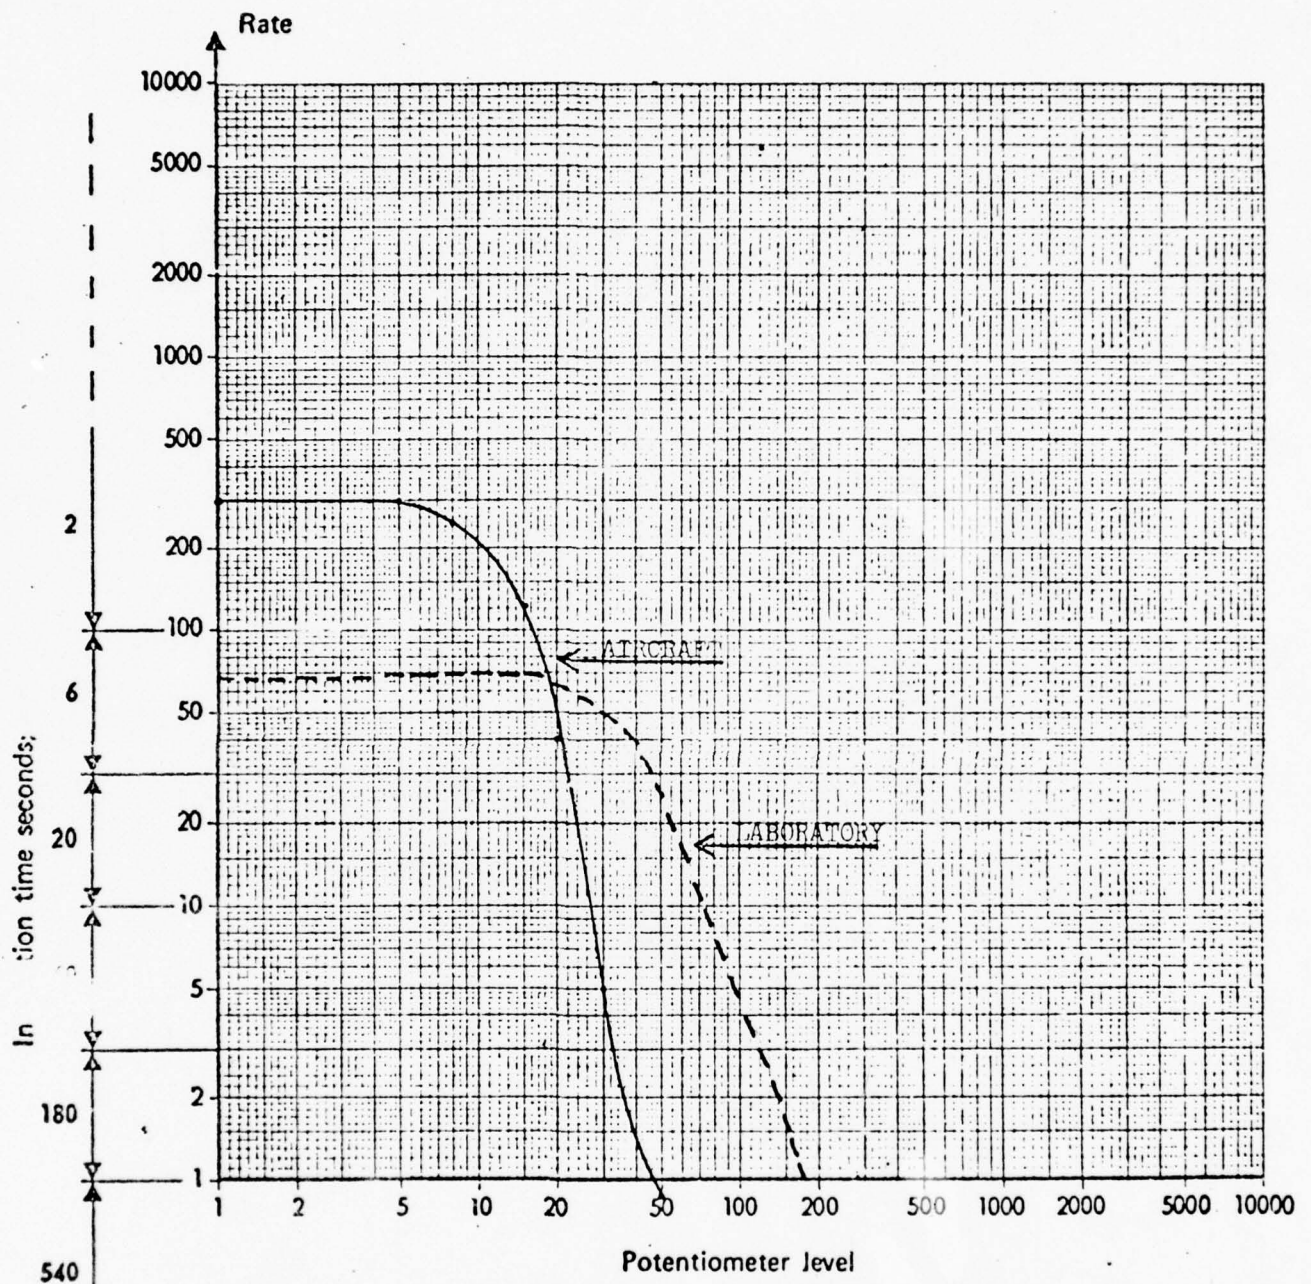
FIG. 14

Of interest, is the data presented in Figure 14. According to the plotted data, the bearing would be classified as satisfactory. However, the bearing was removed by an aircraft technical inspector due to "excessive play." Also shown is data collected from the same bearing on the laboratory bench set-up. The data still appears satisfactory and the teardown analysis did not show significant damage level.

GRAPH OF BEARING #A2037362 WHICH WAS REMOVED FOR ANALYSIS BECAUSE OF EXCESSIVE PLAY DISCOVERED BY AN AIRCRAFT TECHNICAL INSPECTOR - ONE GRAPH MADE ON AIRCRAFT, THE OTHER IN LABORATORY AT APPROXIMATELY THE SAME RPM. (14 DEC 1973).

Very light pitting was evident in both the inner and outer race. No defects were found in the balls according to the Bell Helicopter report and no pictures were taken of the bearing.

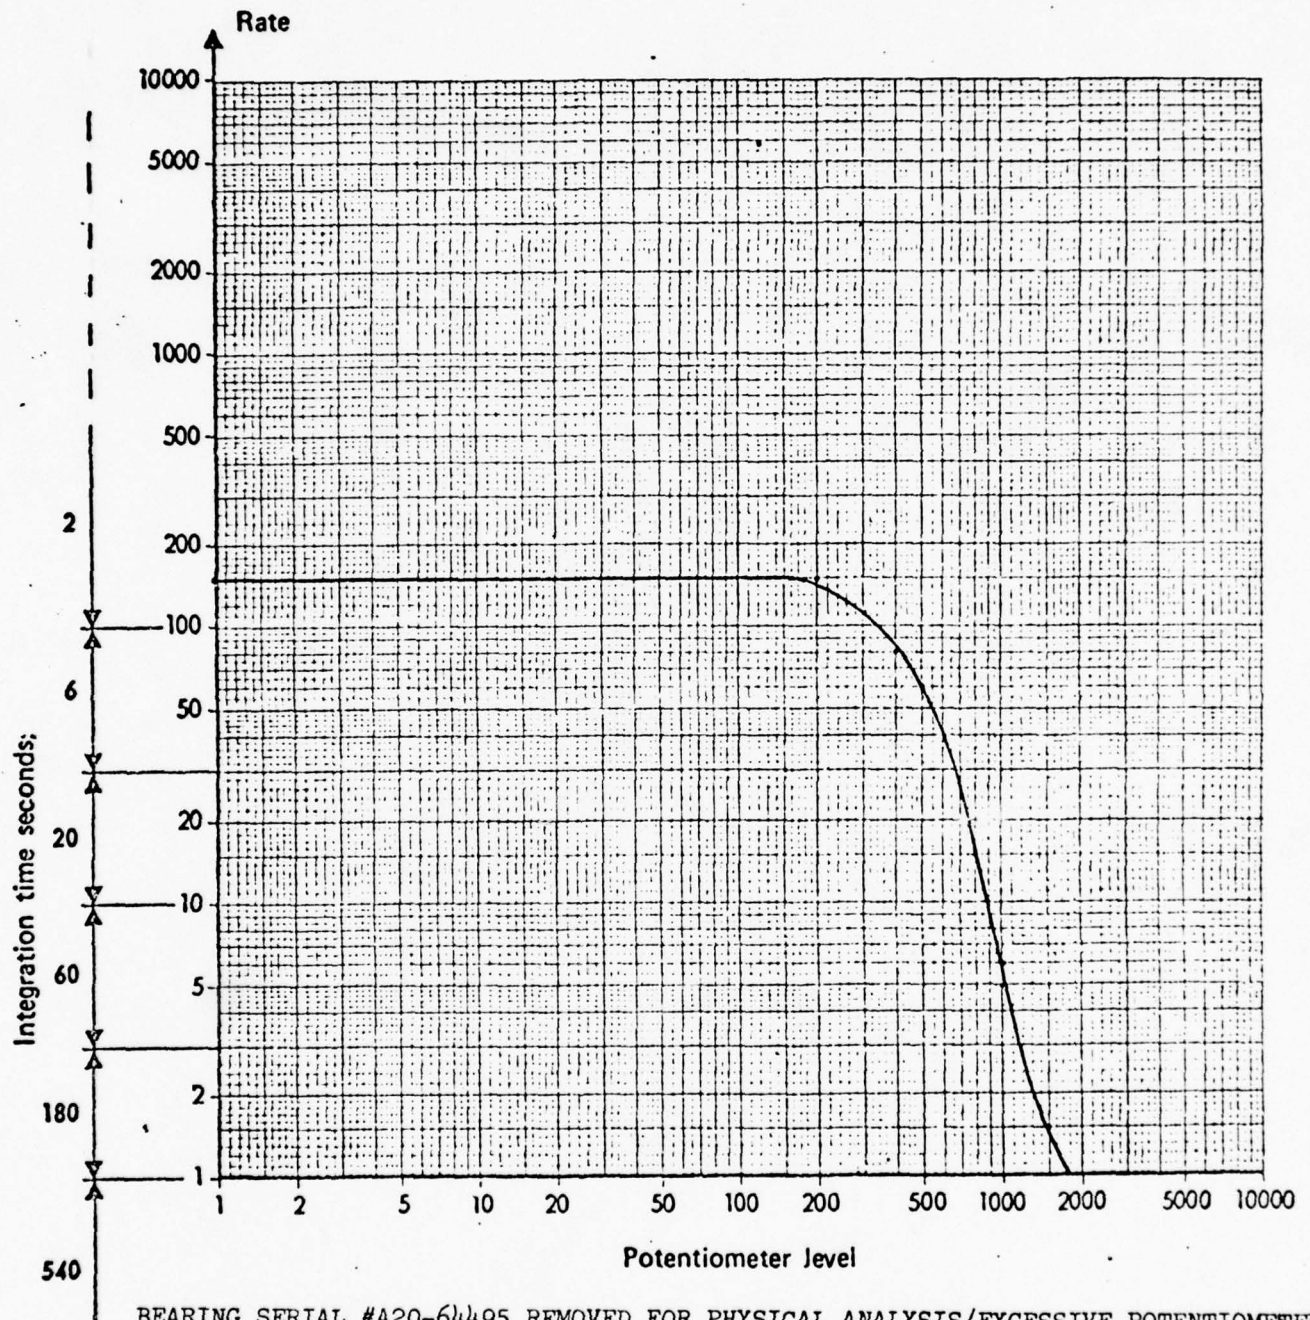
FIG. 15

BEARING SERIAL #A20-64495 REMOVED FOR PHYSICAL ANALYSIS/EXCESSIVE POTENTIOMETER LEVELS NORMAL RATES OF SHOCK.

Both the outer and inner race of the bearing showed evidence of corrosion and pitting. Corrosion was also apparent on several of the balls of this bearing.

The MEPA-10A analysis revealed an excessive potentiometer level of approximately 1800. We would consider a level this high cause for replacement.

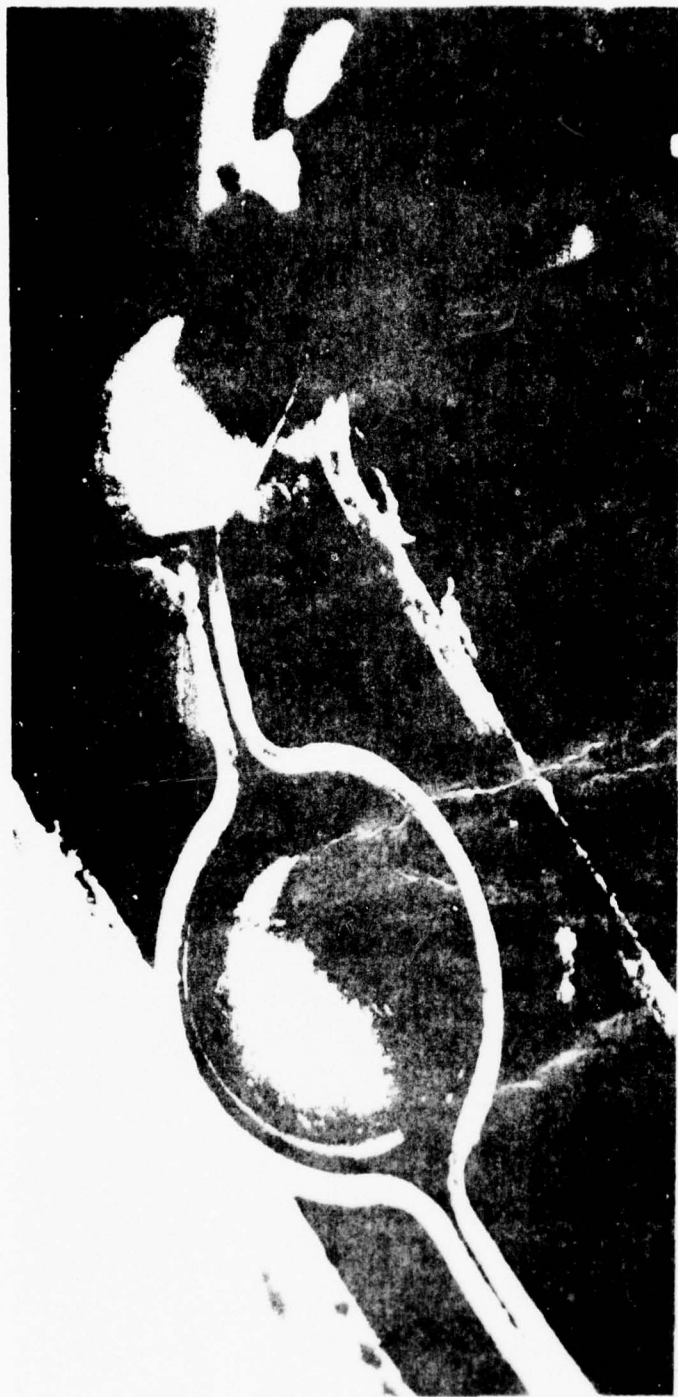
The pictorial evidence of damage on the outer race and balls appears to definitely warrant a replacement of this assembly.

A20-64495 - Corrosion
Damage on Ball Bearing.

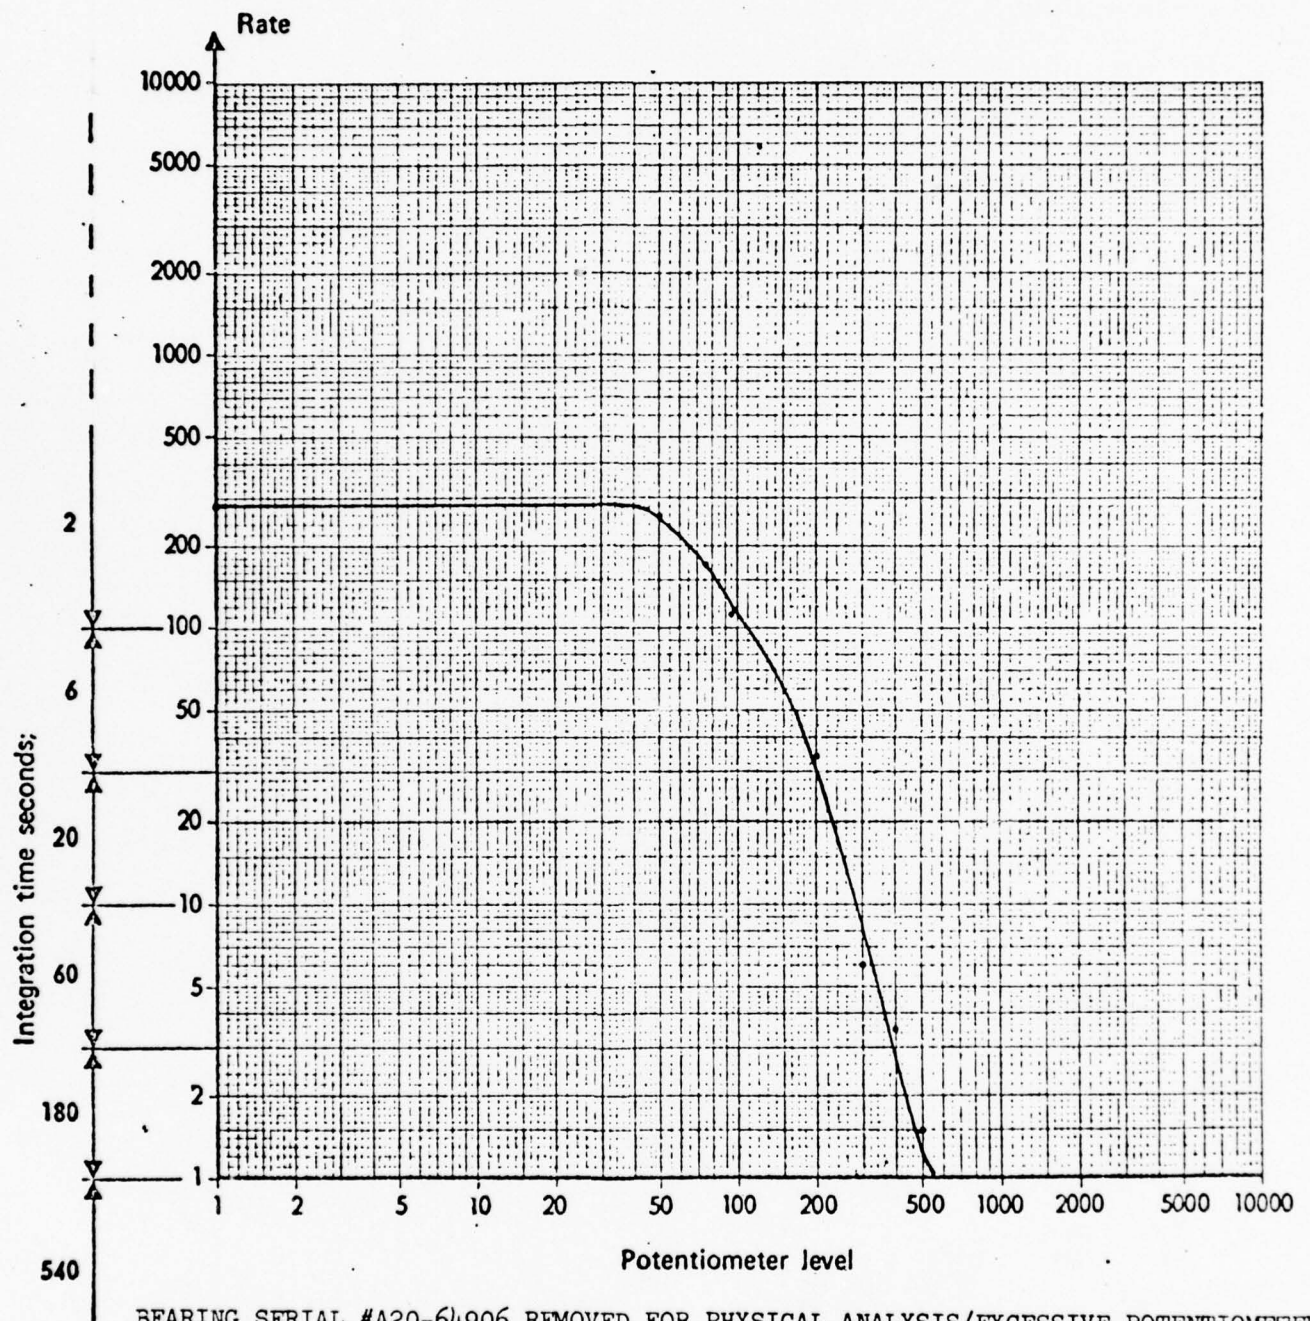
FIG. 16

BEARING SERIAL #A20-64906 REMOVED FOR PHYSICAL ANALYSIS/EXCESSIVE POTENTIOMETER LEVELS.

Pitting was evident in the outer race of this bearing as well as corrosion and pitting on one ball of the rolling element. No defects were found in the inner race of the bearing.

The MEPA-10A shock depiction had a level of 550 and rate of 290. This rate and level while higher than the mean level measured, would not be considered excessive but would be considered approaching an unacceptable condition.

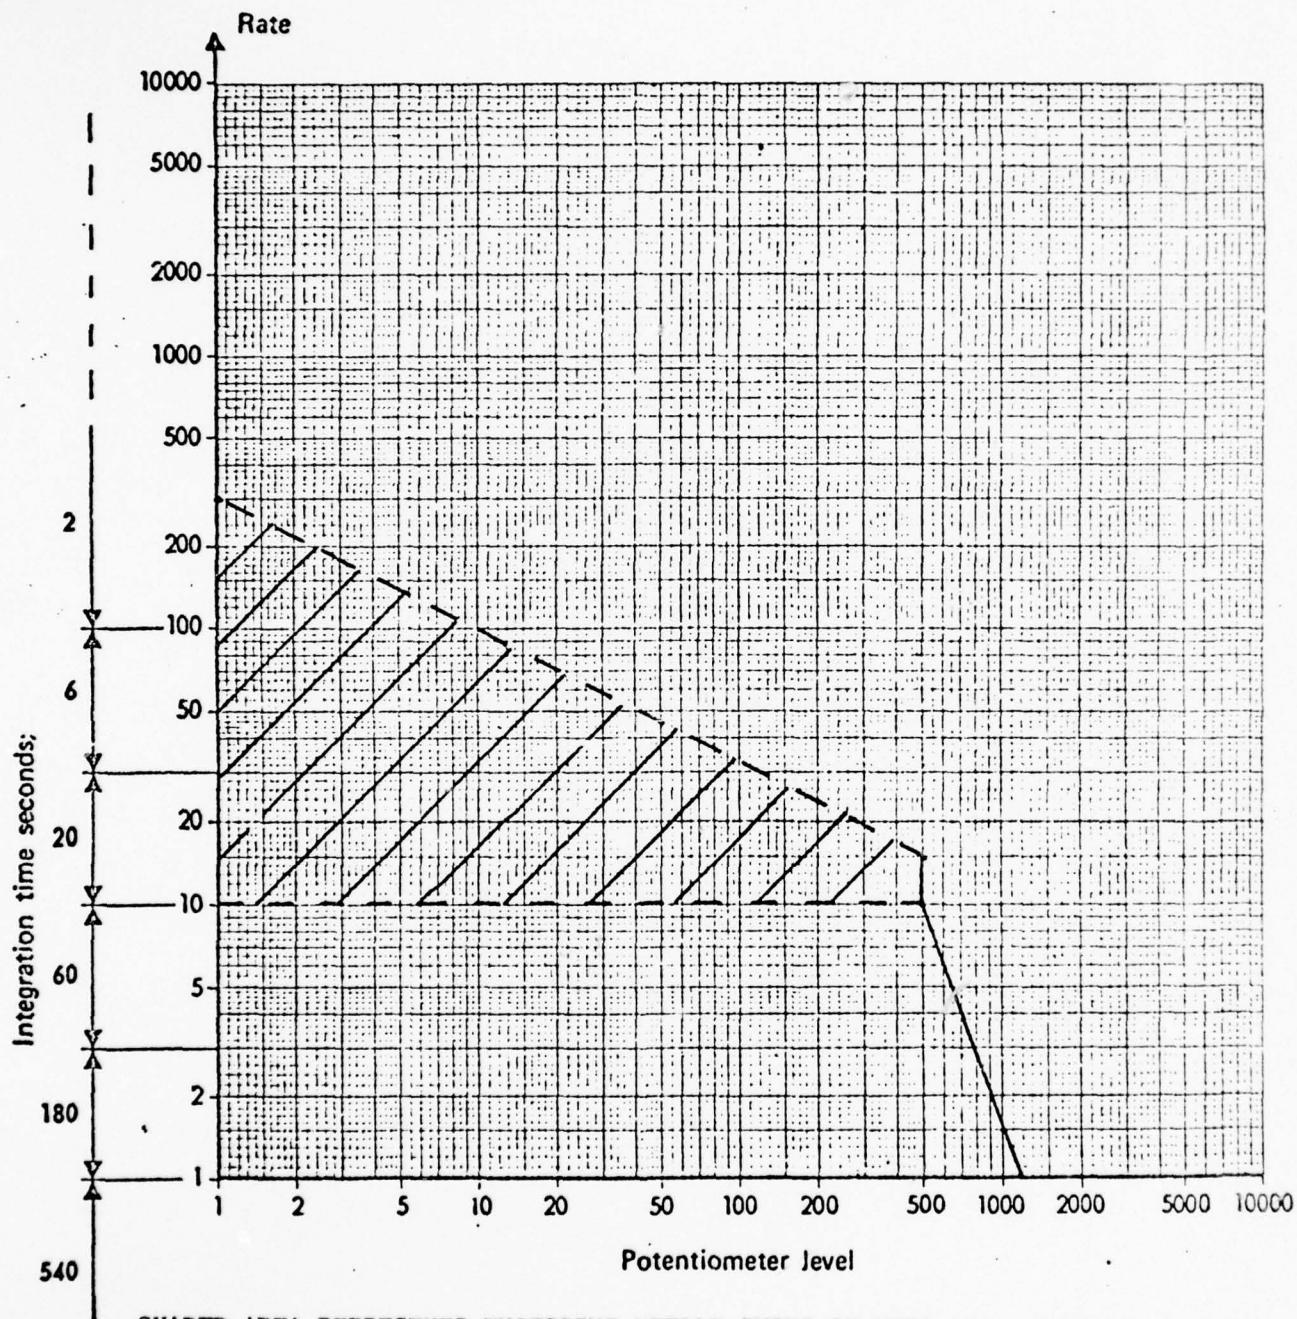
FIG. 19

Hanger Bearing Serial #A20-11446 (Fig. 10) was removed for analysis because of the high potentiometer level of 1200 plotted and the excessive needle swing present in plotting the curve. This was the only hanger bearing which manifested such excessive needle swing on the MEPA-10A shock analysis. Reviewing the teardown data from BHC, a general good condition is reported with the only damage being corrosion in two places

in the outer race. The inability to plot a smooth curve for this hanger bearing cannot be explained at this time. It is the only assembly tested which appears not to correlate with the teardown evidence. On several occasions, needle swing was found in plotting a portion of the curve in the analysis of gearbox assemblies. The swing in these cases was minimal and usually confined to between two or three points on the curve, not the entire curve. More data should be collected to determine how this needle swing affects curve plotting and whether temperature or low electric power supply could be the cause of excessive swing. The slight needle swing found in some of the gearbox assemblies, it is felt, could be because of the multiple bearing and gear assemblies present in the quills as well as accelerometer placement.

SHADED AREA REPRESENTS EXCESSIVE NEEDLE SWING ON MEPA-10A - BEARING REMOVED FOR ANALYSIS.

Teardown analysis yielded a bearing condition described as "general condition good, bearing feels smooth."

Some corrosion is evident in two places in the outer race. The teardown data indicates a bearing in normal condition.

The MEPA-10A analysis shows an excessive needle swing in rate depiction ranging from a rate of 10 to 300. The potentiometer level of 1200 would be considered high and excessive when compared to the other bearings evaluated. It was for this reason the assembly was removed for analysis. The cause of excessive needle swing in measurement of shock rate is not known. The plot of this bearing was not made up of defined points which the curve developed through, and thus differs from other bearings which exhibited some needle movement. Teardown information would lead to the conclusion that the bearings was in a serviceable condition.

The ability of the MEPA-10A to plot a curve of shock emission which did not have the erratic nature seen in this curve is desirable, in order to confirm the bearing condition. Possible reasons for the excessive needle swing includes an ambient air temperature below 30°F and the possibility of a less than sufficient power source.

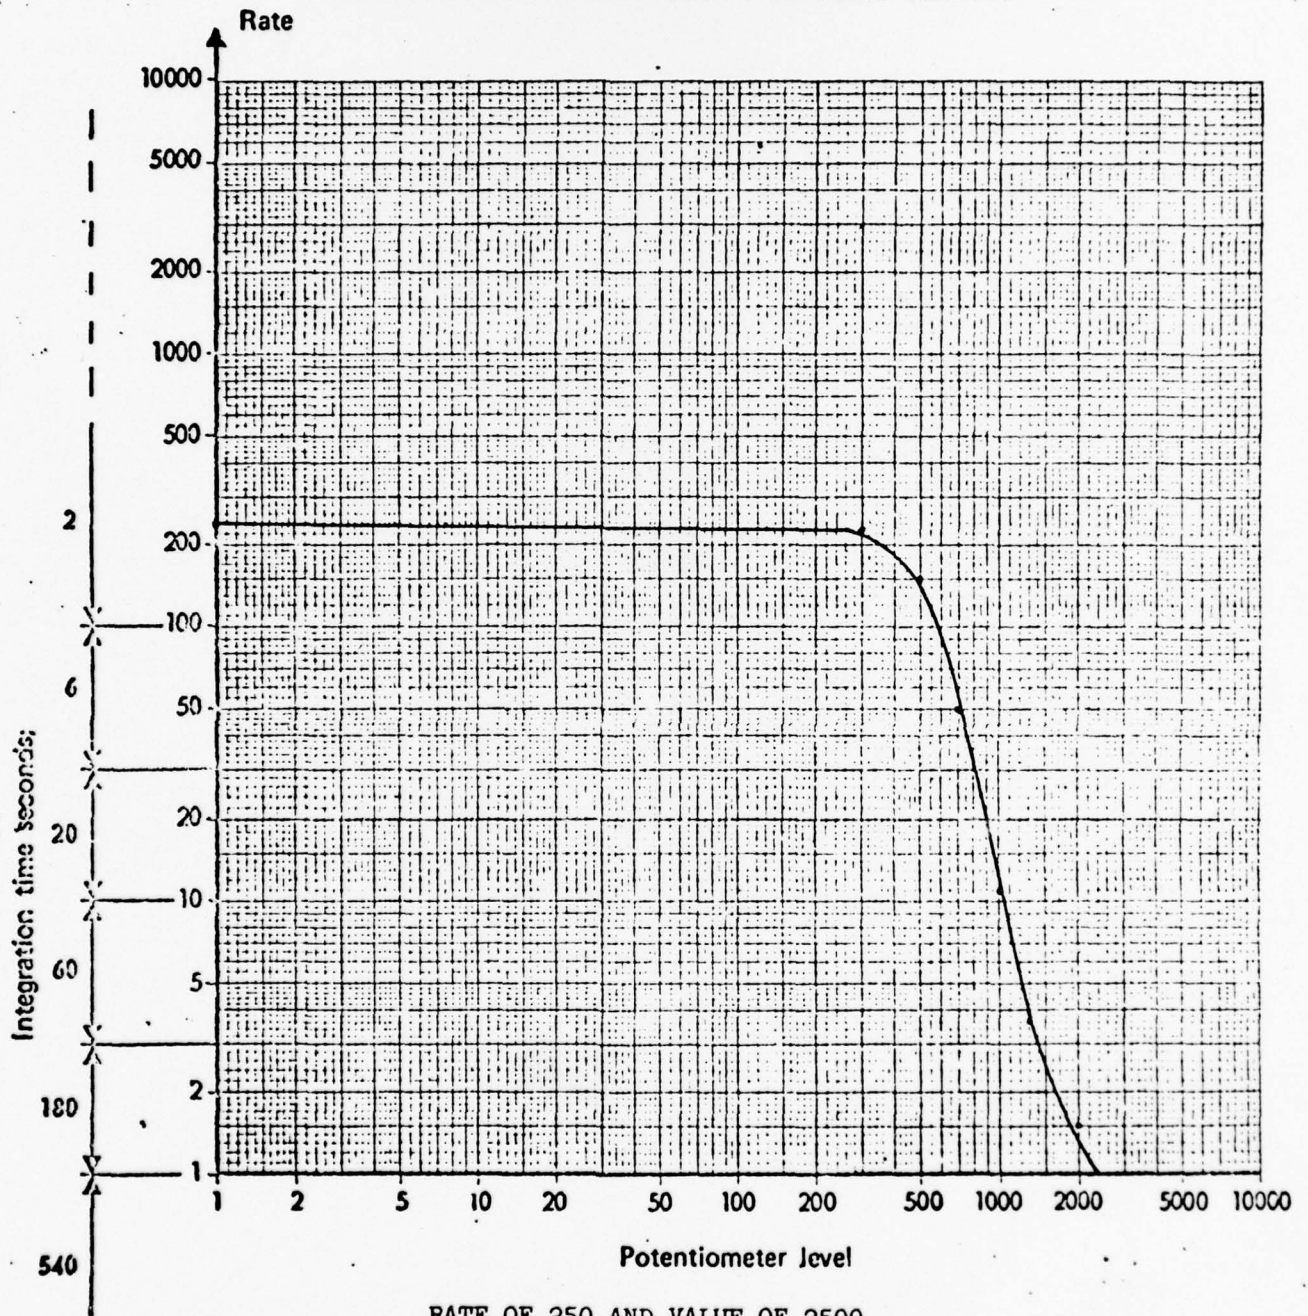
FIG. 29

RATE OF 250 AND VALUE OF 2500
BEARING-REMOVED FOR ANALYSIS

Both corrosion and pitting are evident on the outer race of this bearing. No defects were noted on the inner race, however, the rolling element also had evidence of corrosion and pitting.

The potentiometer level of 2500 reached was the second highest of all bearings tested although the rate attained was not excessive at 250. The plot of the curve derived from the MEPA-10A shock analysis system would warrant the conclusion that this bearing would be considered excessively damaged when compared to the normal amount of shock emission of all bearings tested. Pictured damaged in the outer race would seem to indicate a bearing which was damaged to the point overhaul is warranted.

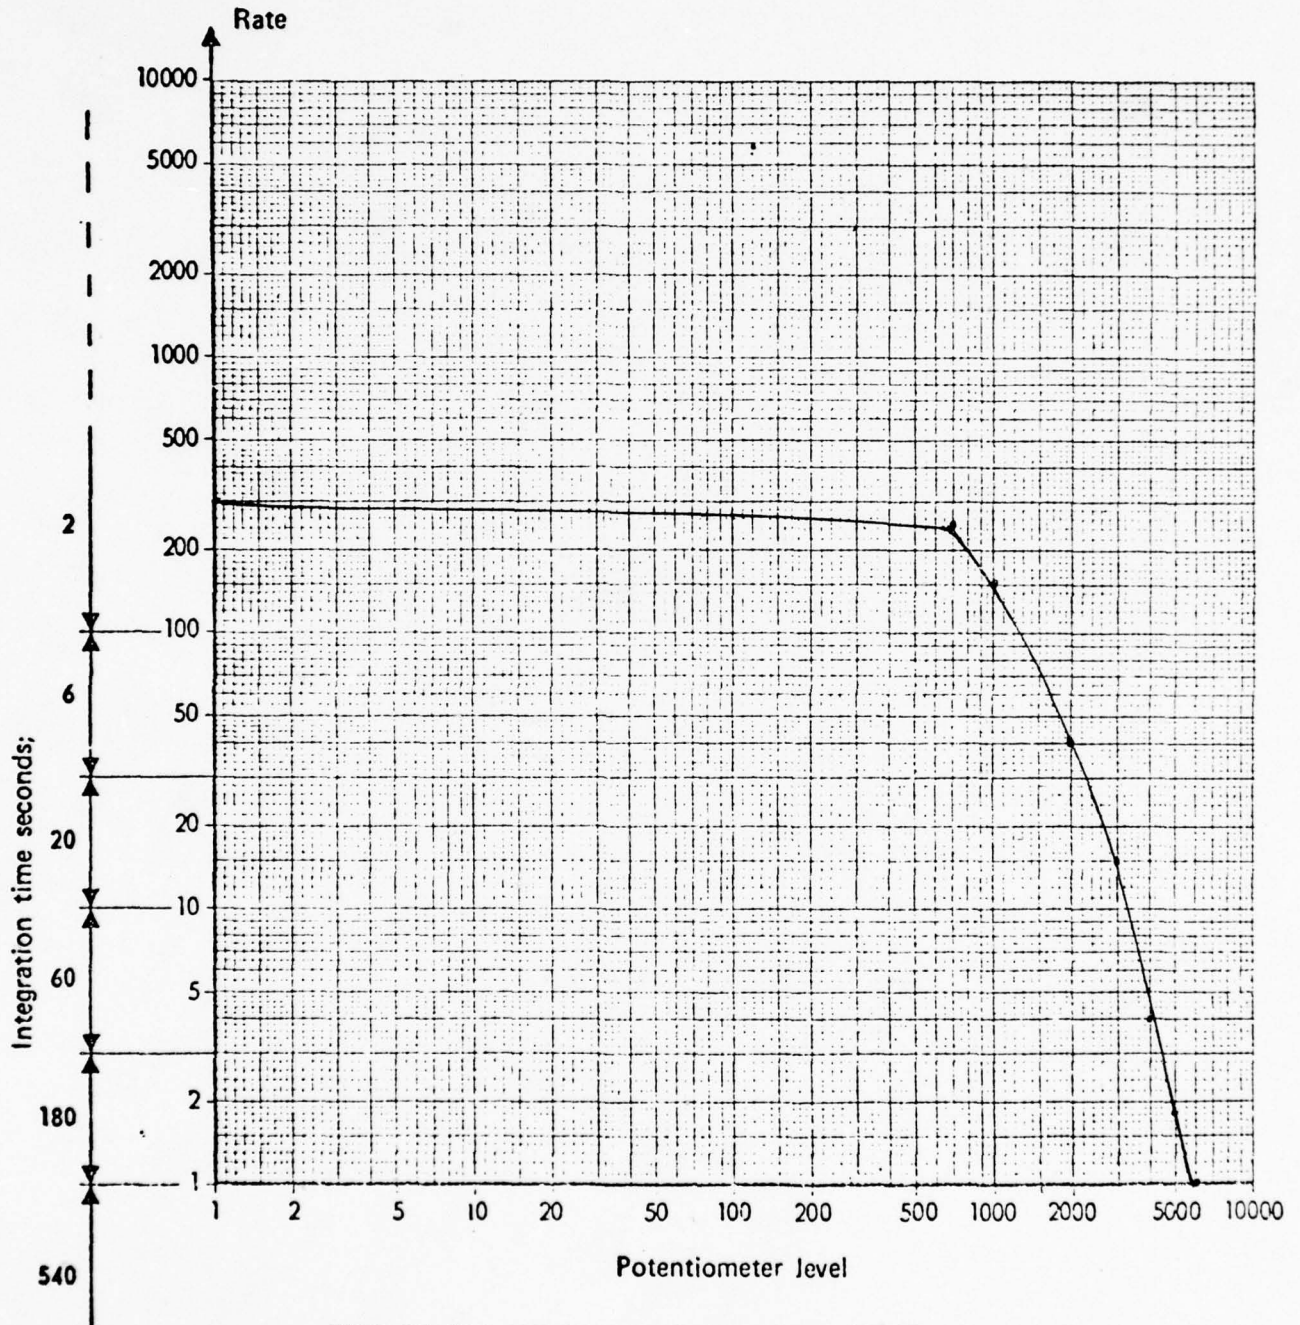
FIG. 30

RATE OF 300 AND VALUE OF EXCESS OF 6,000
BEARING REMOVED FOR ANALYSIS

The teardown report stated "bearing rotated roughly before tear-down." Corrosion and pitting was in evidence in all the bearing elements, inner and outer races as well as rolling element damage. Damage can be clearly seen in the teardown photos and this bearing must be considered as excessively damaged.

The MEPA-10A shock profile showed the highest potentiometer level recorded on this bearing. A level of 6500 should be considered excessive and with the photo and teardown data reviewed, this bearing must be placed in a severely damaged category.

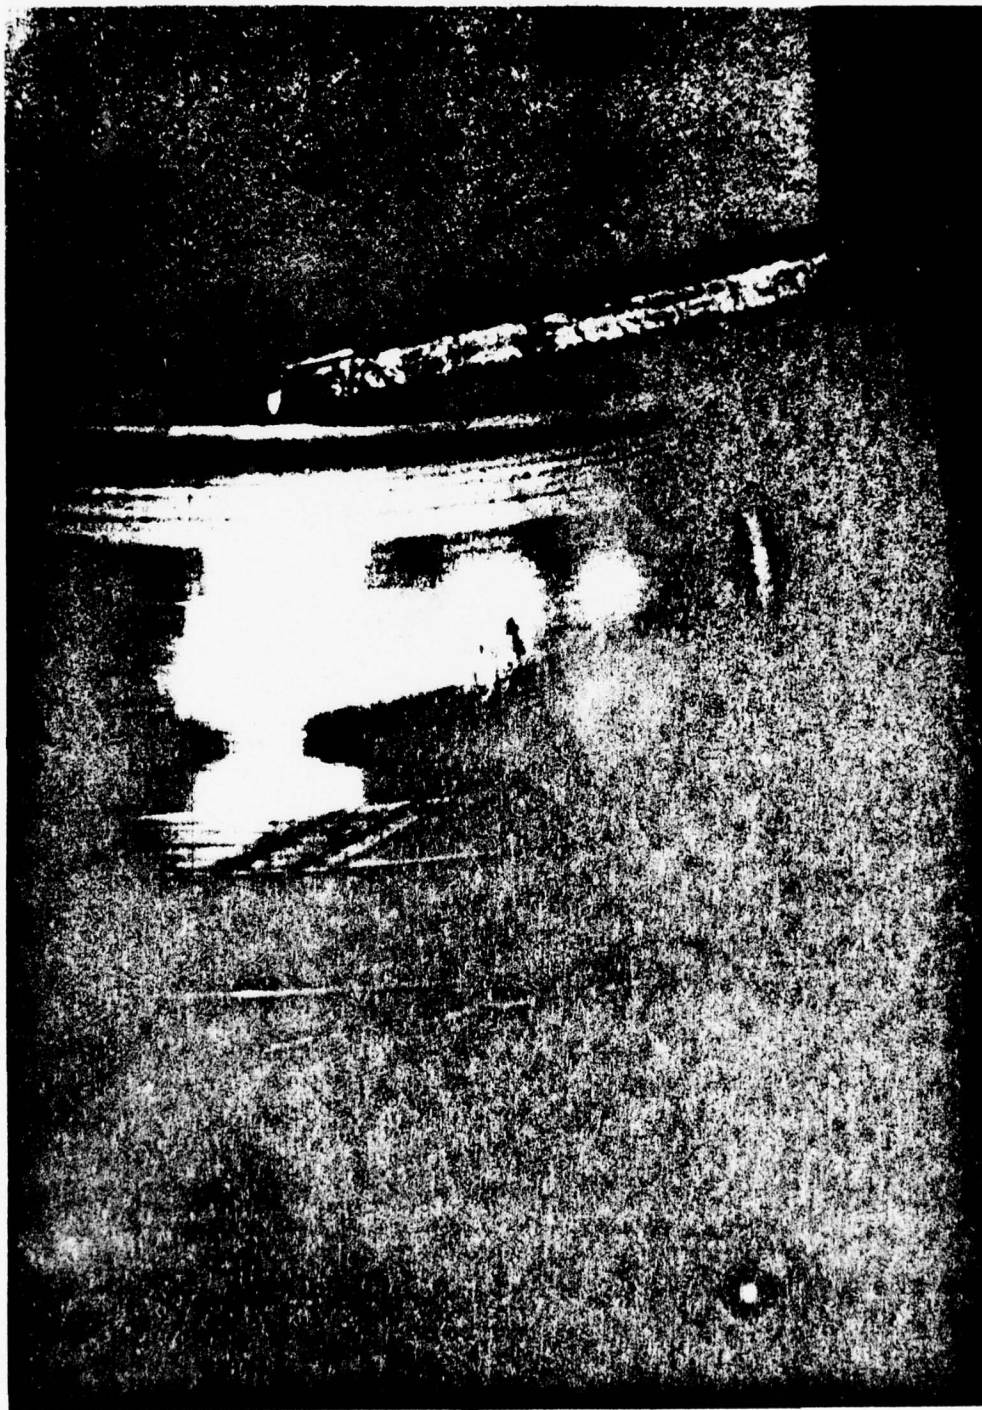
A20-31225 - Corrosion and
Pitting on Outer Race.

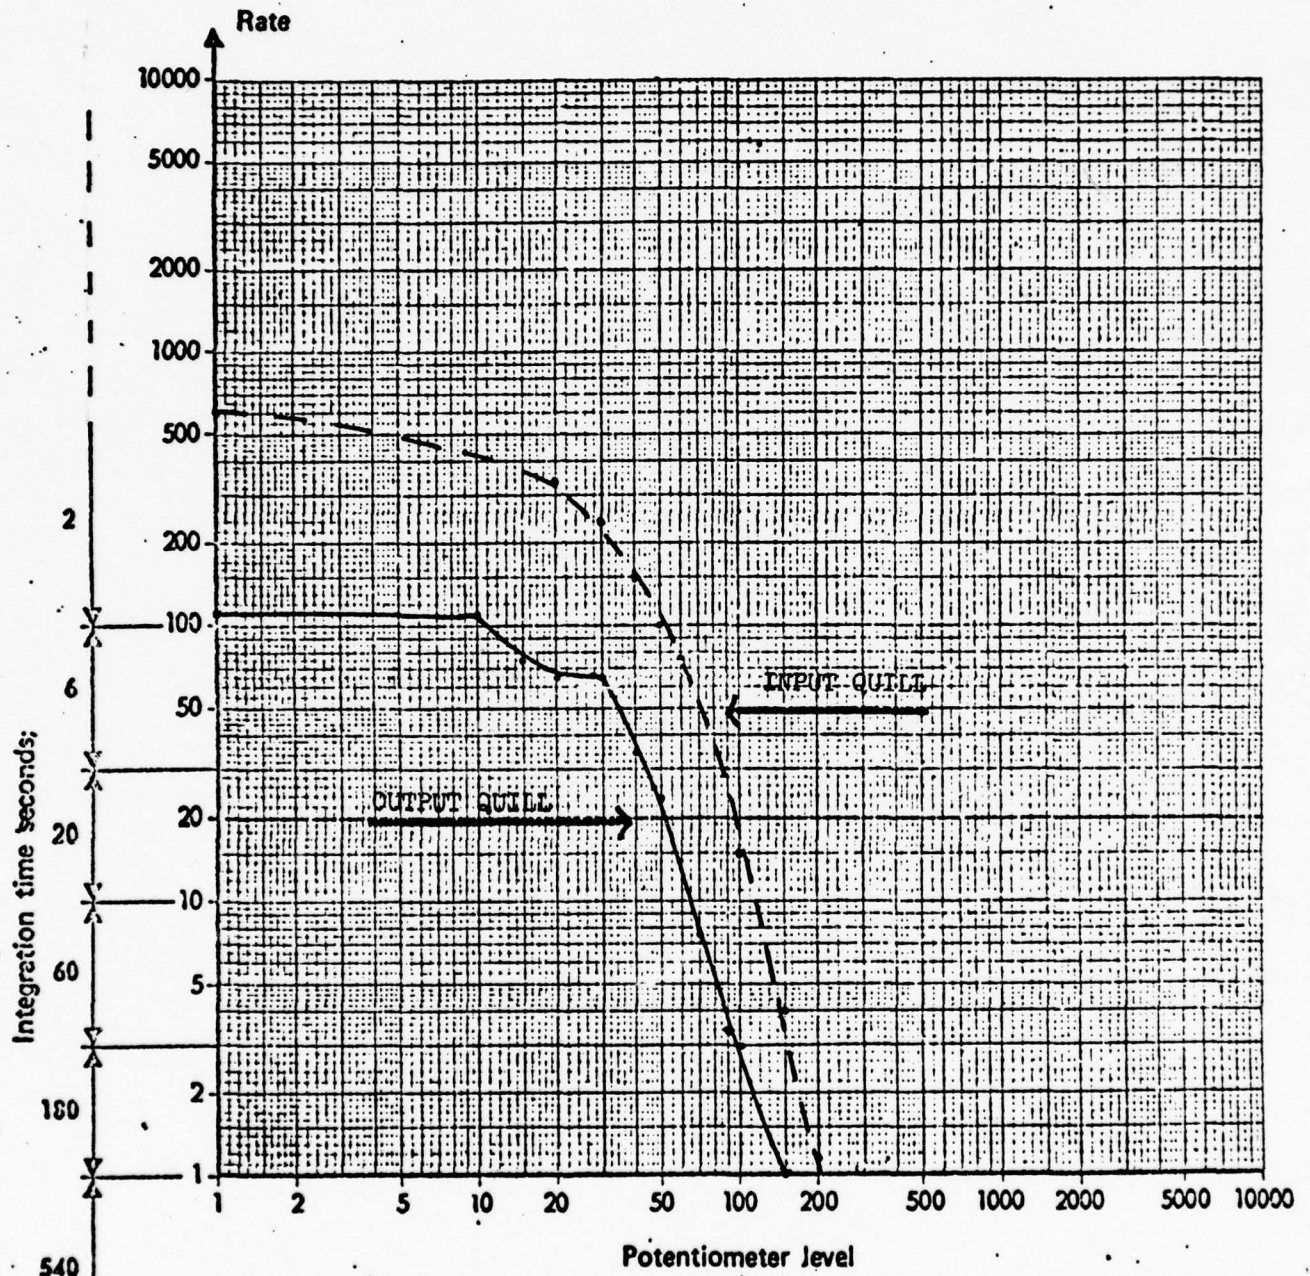
ONE CURVE DEPICTS INPUT DRIVE QUILL, THE OTHER THE OUTPUT QUILL GEARBOX REMOVED FOR TEARDOWN ANALYSIS.

The bearings in the output drive quill (S/N 12-737) were stated as feeling smooth, however, brinelling was found on the load side of the inner races. The bearings operated over the damage and the rolling element path is now continuous.

The bearing in the input drive quill (S/N 76-961) had no evidence of damage or deterioration during teardown.
